CALIFORNIA REGIONAL WATER QUALITY CONTROL BOARD - SAN DIEGO REGION  
STORM WATER PROGRAM

FACILITY INSPECTION REPORT

INSPECTION DATE: 01/11/01 TIME: 11:30 WDID: 9335313938

North Plaza  
FACILITY OR DEVELOPER NAME (if different from owner)

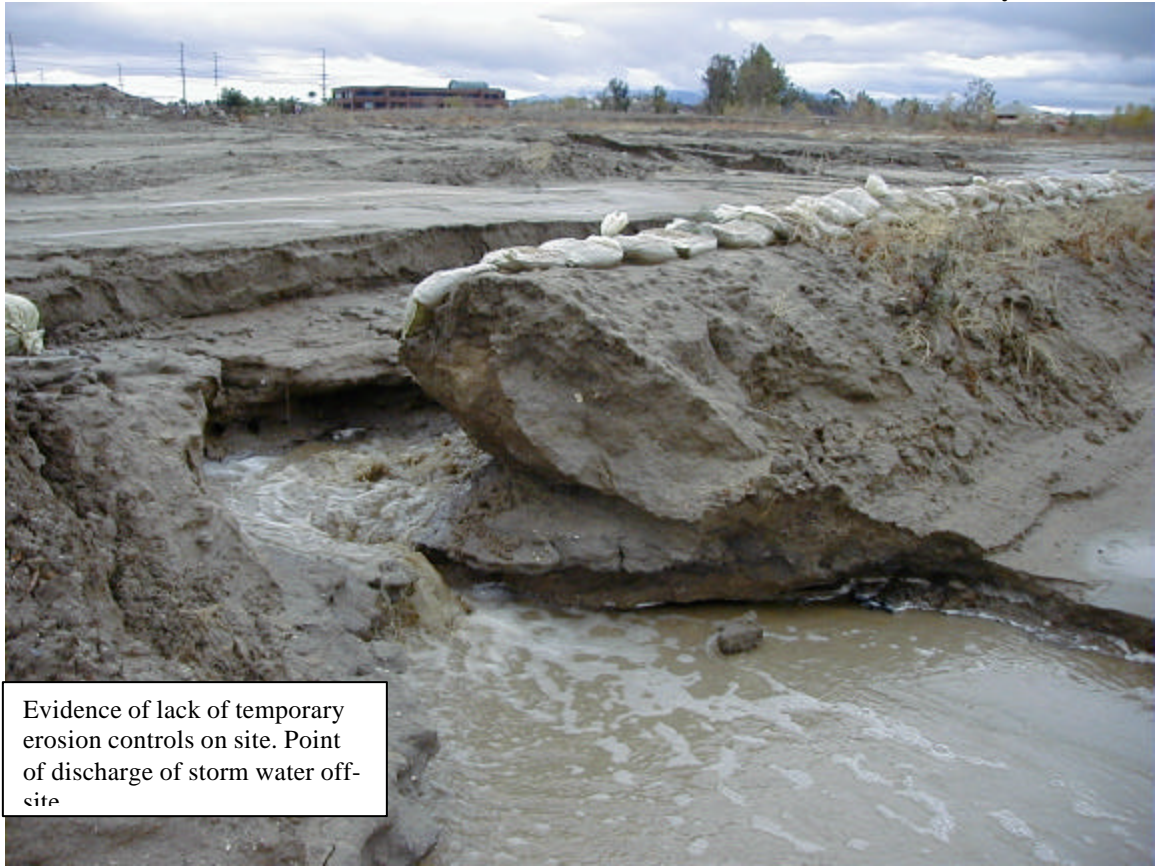
Evidence of lack of temporary erosion controls on site. Point of discharge of storm water off-site

Implement BMP's to address violations, stabilize perimeter of site to prevent sediment discharge off-site.  
Amend SWPPP to section A of General Construction Permit Order NO. 99-08-DWQ. send copy of amended SWPPP to Regional Board for Review.

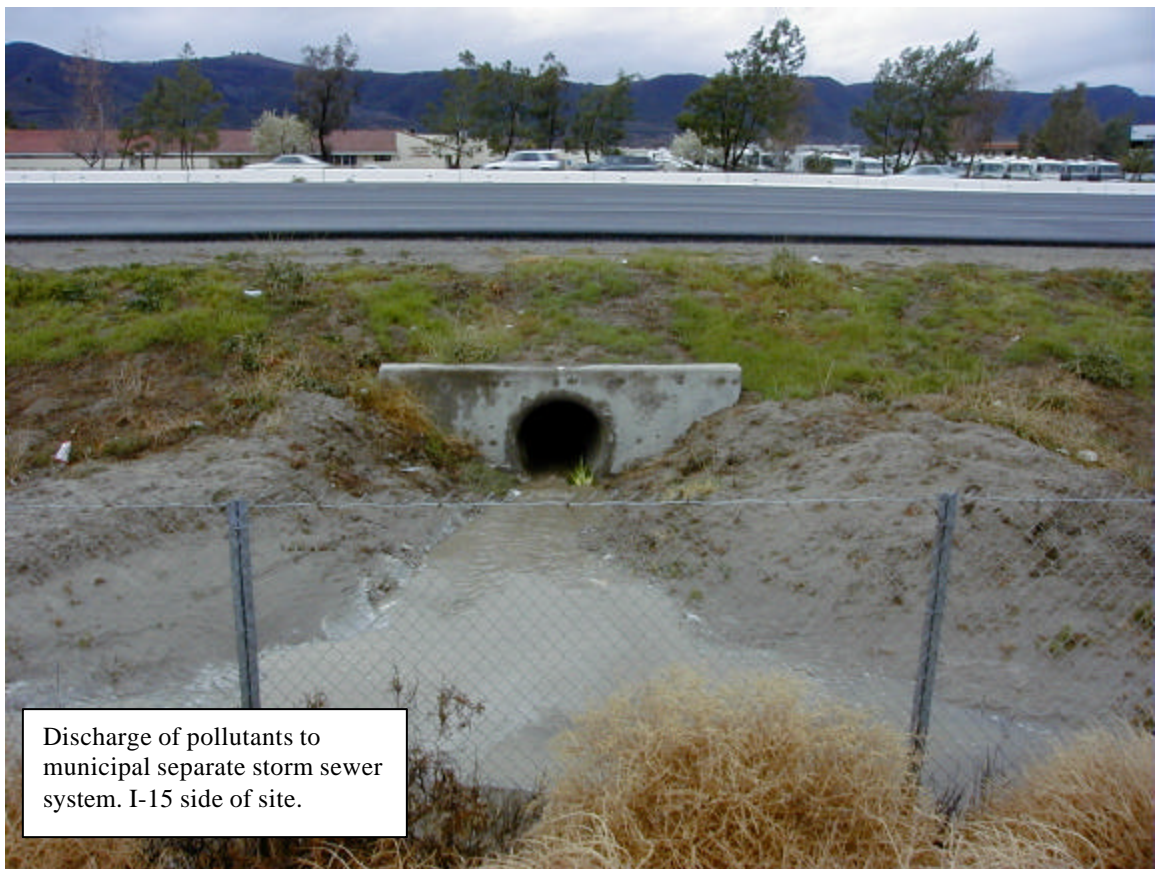
Discharge of pollutants to municipal separate storm sewer system. I-15 side of site.

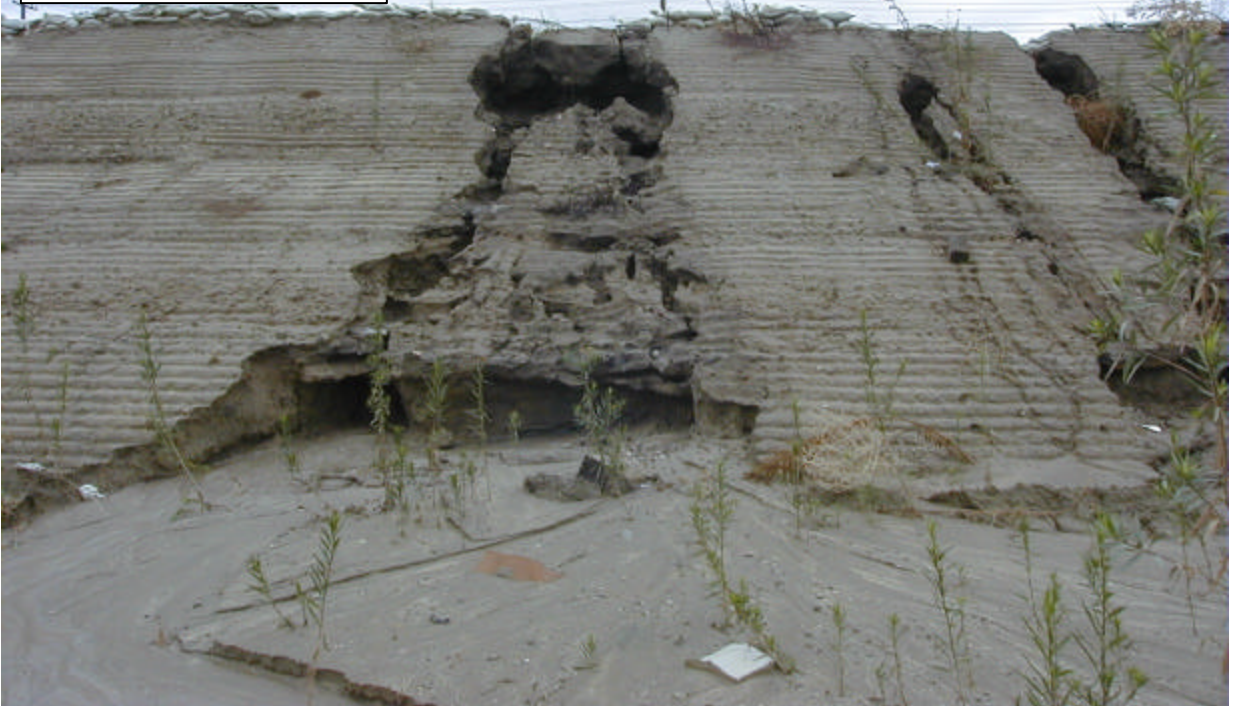
Lack of temporary erosion control BMPs on finished slopes resulting in block failure of slopes. West side of site.

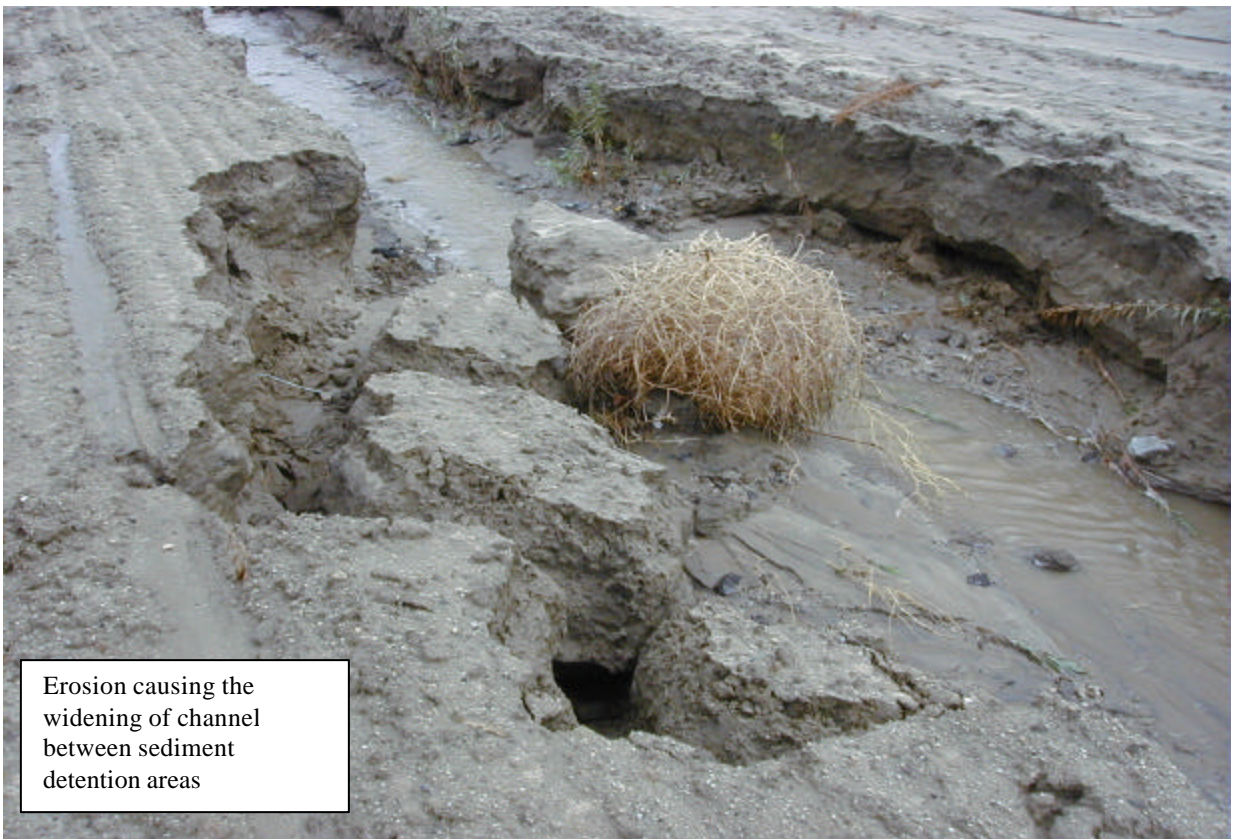
Erosion causing the widening of channel between sediment detention areas

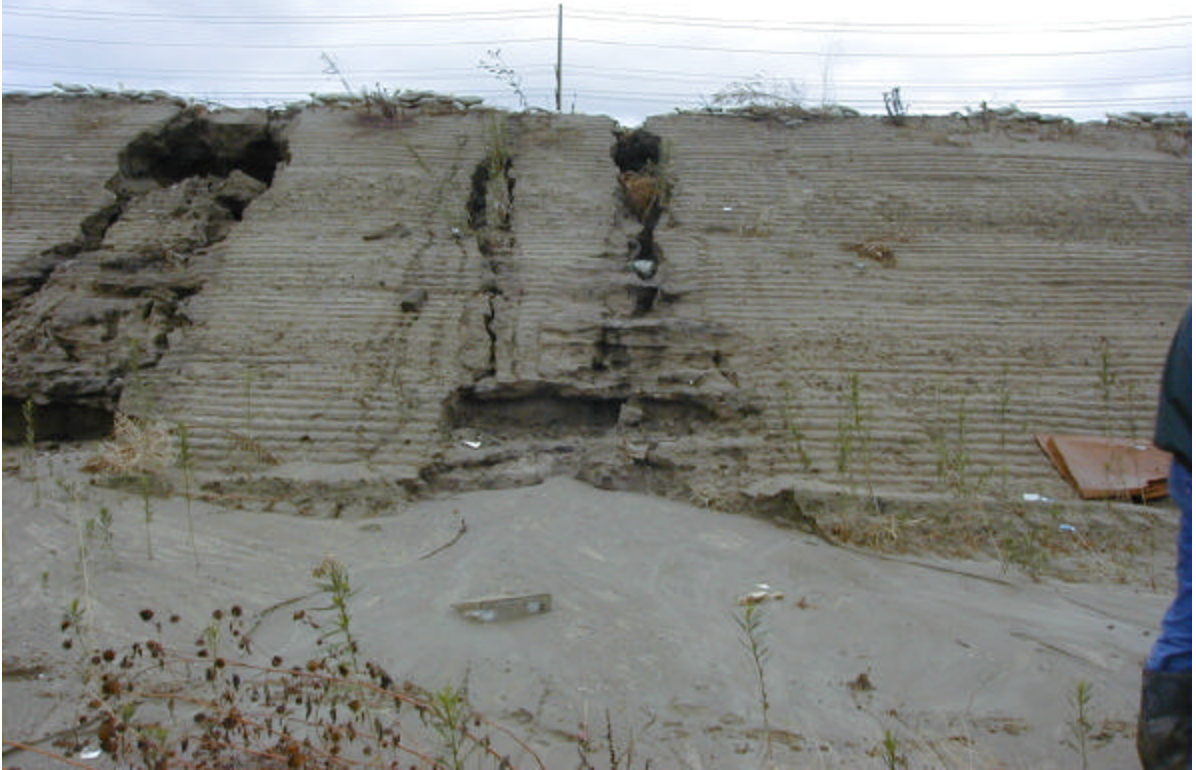
Gully erosion due to lack of temporary erosion controls

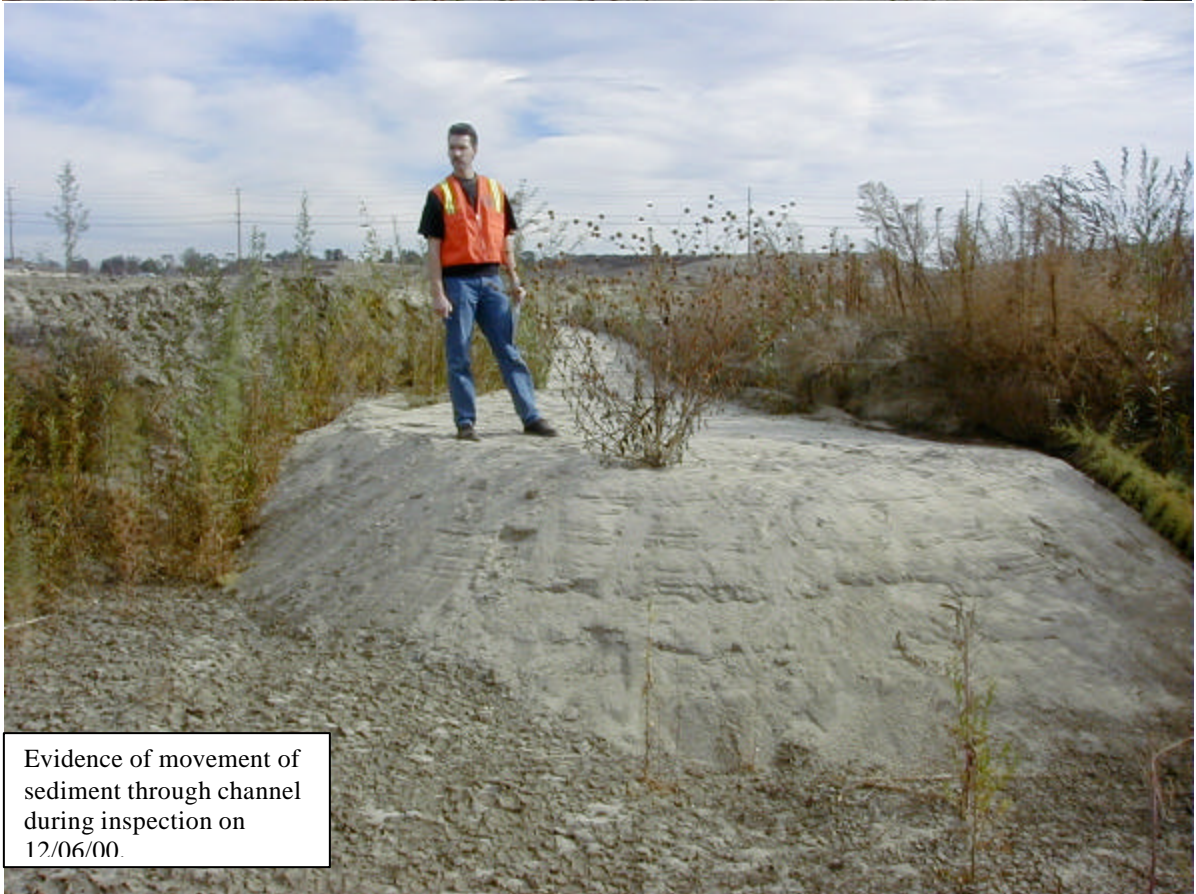
Evidence of movement of sediment through channel during inspection on 12/06/00.

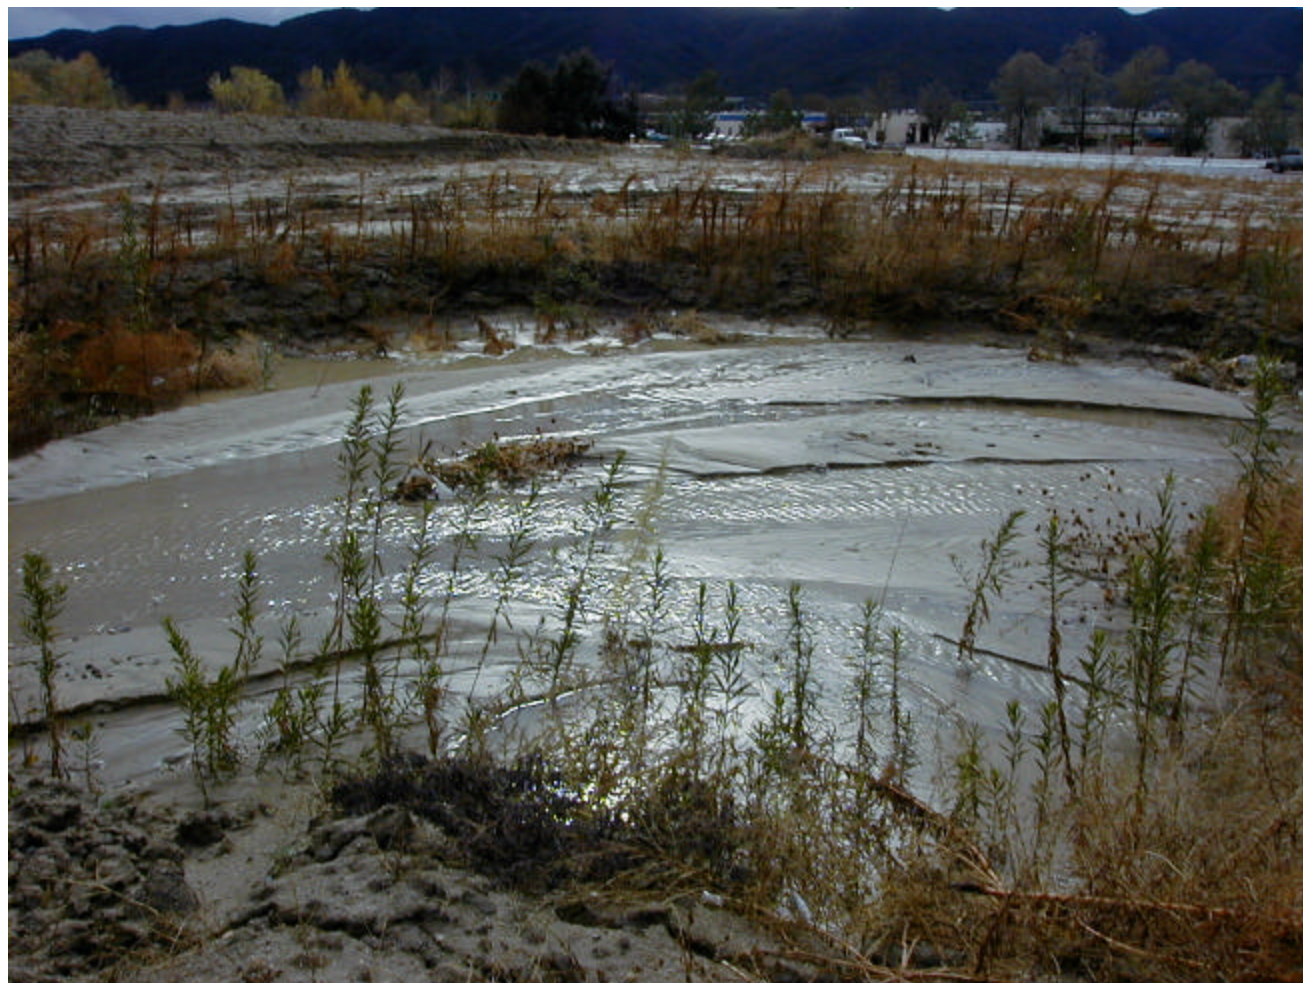
Same area as pictured above.  
Note that area has been  
completely been filled in by  
movement of sediment due to  
rain event. 01/11/01
